APPENDIX A: EXISTING CRITICAL INFRASTRUCTURE

APPENDIX D: CHANNEL MIGRATION ZONE ANALYSIS

NHC Ref. No. 2003907

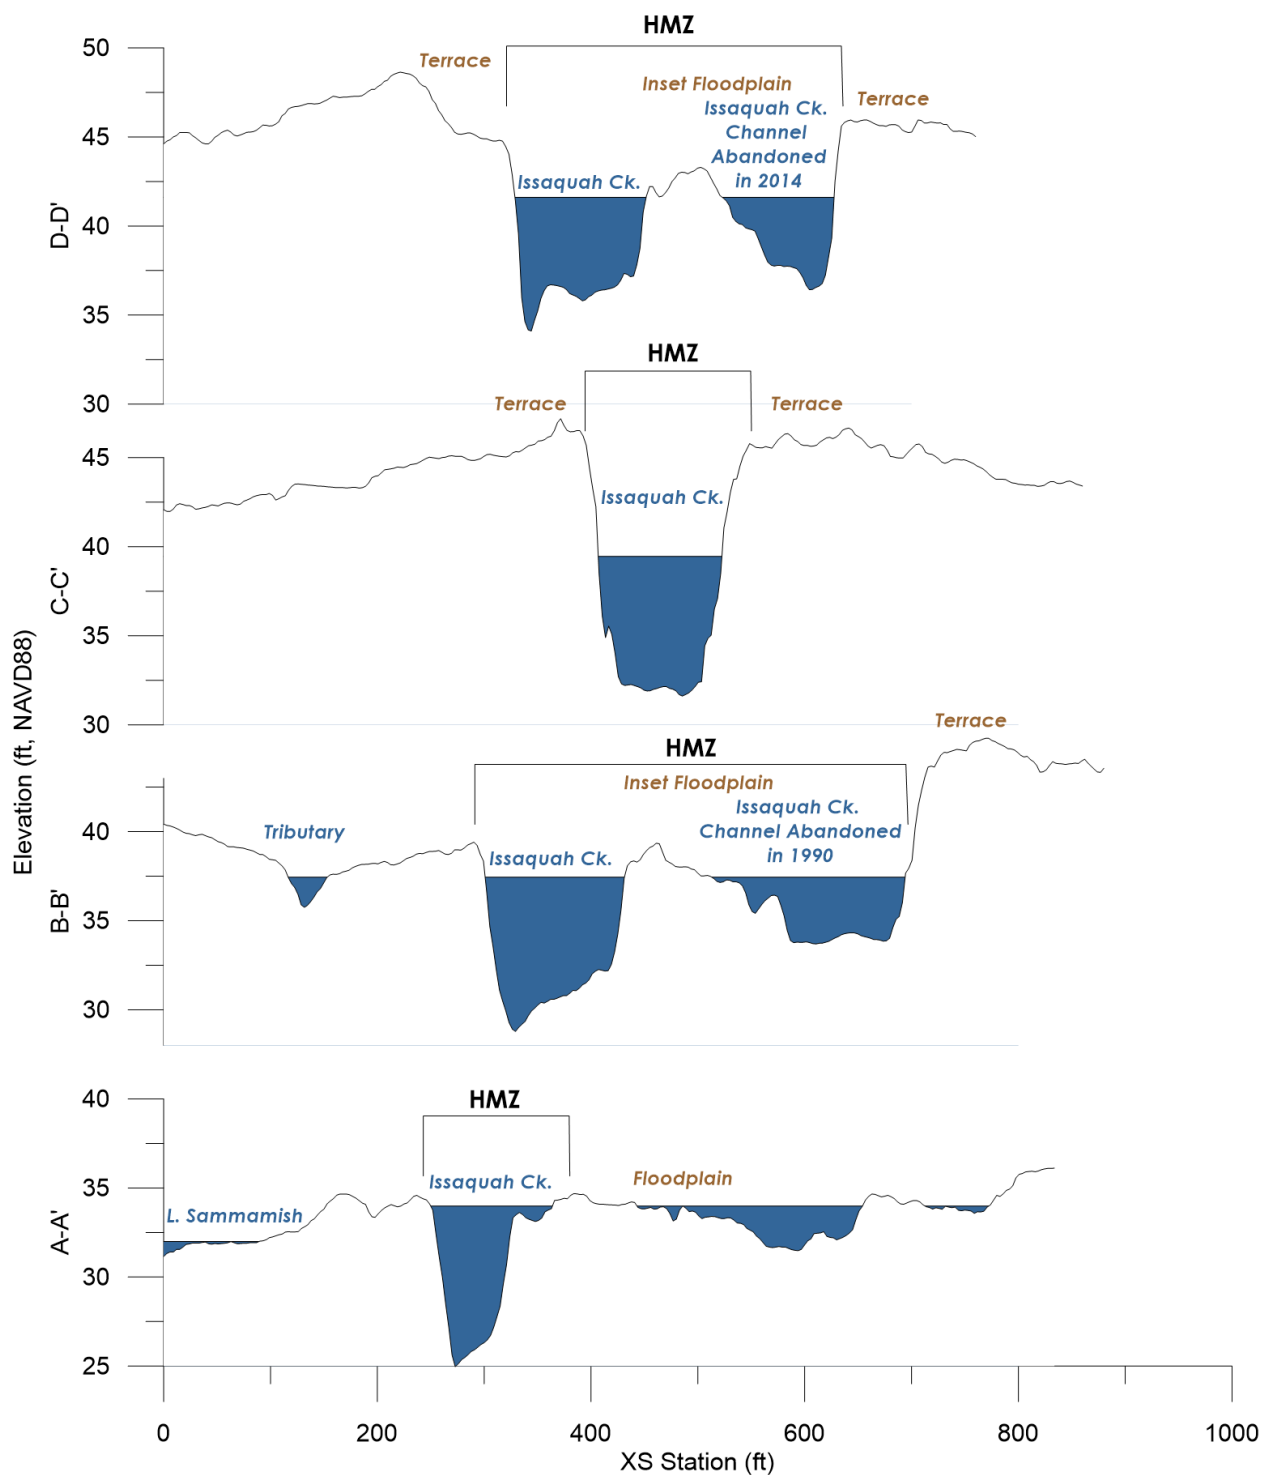
Figure 3: Select cross sections showing the pattern of historical incision and inset floodplain formation. Cross section locations are shown in Figure 1.

The creek is presently incised up to about 12 feet below the surrounding alluvial surface (Figure 2 and Figure 3). This incision is interpreted to be mostly a result of a late 19th century or early 20th-century avulsion or realignment of the creek. The General Land Office Survey (1864) and present-day topography show a historic channel position along the top of the alluvial ridge to the east of the present channel from about Station 4,000 to Lake Sammamish (Figure 1). This alignment was historically about 1,000 feet longer than the present channel. Based on the observed and inferred slope along the historic alignment, the avulsion would have lowered the base level for the channel upstream by approximately 10 feet (Figure 2). A 1937 aerial photo shows the channel close to its current position, indicating the avulsion occurred between 1864 and 1937.

The banks at the outside edge of the CMZ are relatively high (up to 12 feet above the bankfull water surface Figure 2 and Figure 3). The edge of the CMZ represents the edge of the active channel and so in areas where the bank height is substantially higher than the bankfull water surface, geotechnical relaxation of the slope outside of the delineated CMZ is expected. A formal geotechnical assessment should evaluate slope stability above the channel thalweg elevation starting from the edge of the CMZ as a part of the design process for any structure foundations situated near the edge of the CMZ.
